P&S Marine Repair & Supply, Inc.

Nautical Times

Monthly Newsletter - February 2025

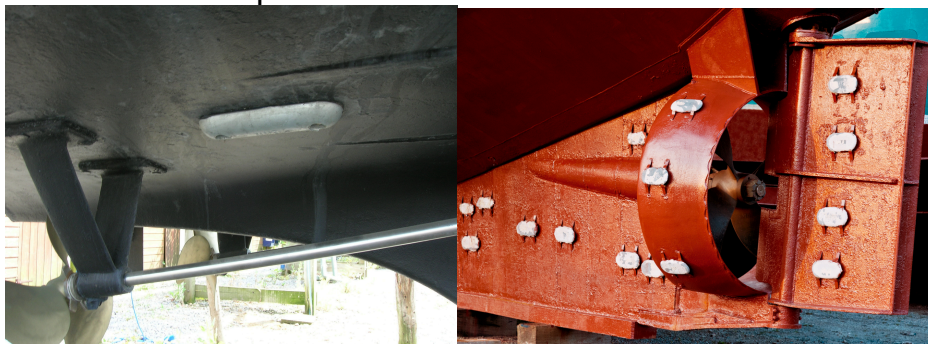
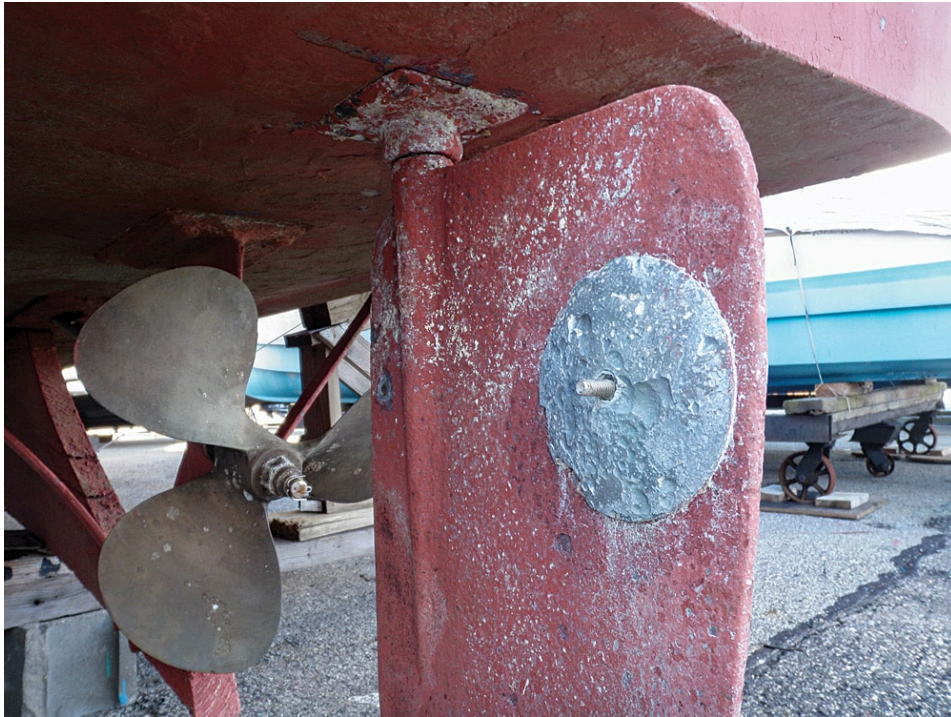
Sacrificial anodes are made of alloys that are more vulnerable to the effects of galvanic corrosion and are intended to corrode more easily, or “sacrifice” themselves, to protect the adjacent aluminum material. Sacrificial anodes are made of materials such as aluminum, magnesium and zinc. Zinc anodes are commonly used on boats operated in saltwater or brackish water.

Magnesium anodes are frequently used in freshwater-only applications. Aluminum anodes are a popular all-around choice that can be used effectively in all water conditions. They also tend to be the lightest and least-expensive option for most applications.

A common misconception among some boat owners is that non-corroded anodes are a good sign that corrosion is not occurring. In fact, the opposite is true. If your anodes show no signs of wear or corrosion after extended use in the water, that may be an indication that damaging corrosion is occurring on other more critical components. If this happens to your motor, check the anodes closely. They may be dissipated, coated with scum or marine growth, or otherwise not functioning and should be replaced.

- Anodes look like a small gray block and are usually secured with one or more bolts.
- Some anodes are grounded to the engine case with a wire or strap. If yours are grounded, be sure to reattach the ground strap when replacing the anode.
- Anodes may become coated with a thin film of scum in some water conditions. This film can be removed with a stiff brush.
- Anodes must be in direct contact with the water to work properly, **so never paint or apply other coatings over them**. Either remove or tape over them when painting the surrounding area.
- Replace anodes when about half of the material has been lost to corrosion. To get the best protection for your boat, always use quality anodes.

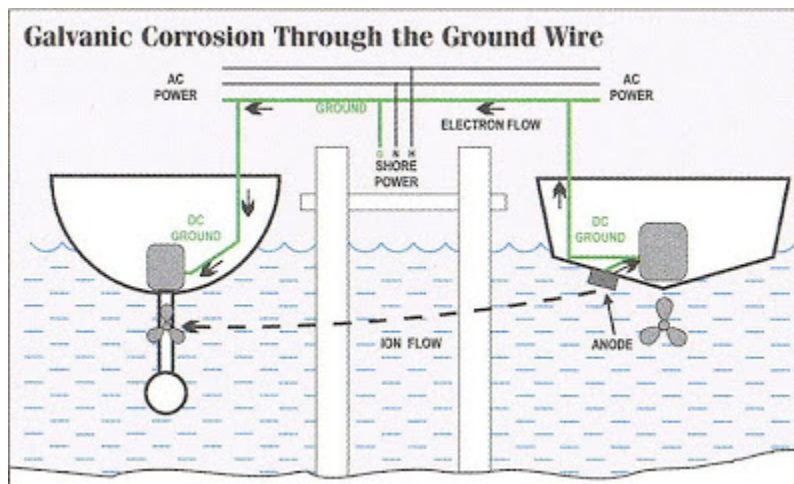
Enter the galvanic isolator. Although not as capable as an isolation transformer, the galvanic isolator can go a long way toward extending sacrificial anode service life and mitigating corrosion, at much lower cost and nearly insignificant weight compared to the transformer. If your boat is plugged into shore power on a regular basis, you need a galvanic isolator installed in your shore power system.

Remember that the galvanic isolator needs to be able to fulfill multiple roles in your boat's AC shore power system. Eliminating one of the components that make up a galvanic cell is one of its functions. But because it is installed in series with the green grounding conductor in your boat's AC shore power system, it must also ensure that electrical continuity is always maintained in that wire.

For that reason, the American Boat & Yacht Council (ABYC) has some strict guidelines in its standard addressing galvanic isolators. The isolators must be rated for system amperage, usually 30 or 50 amps. They must be hard wired into the system without the use of any friction type connections and meet a series of design specifications to ensure that they can never inadvertently open circuit, effectively eliminating the all-important safety ground for your boat. The newest designs incorporate technology that can identify these units as "fail safe." Simply put, this designation ensures that even after something as significant as a lightning strike, the galvanic isolator will maintain continuity of the safety ground on board your boat. It may not continue to protect your underwater metals, but the safety ground will be intact, one reason why a galvanic isolator should be regularly checked for proper function.

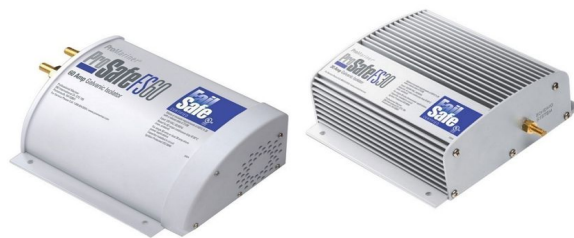
Here are a few examples of Galvanic isolators that we use on a great deal of our customers boats. The Pro Mariner 30amp and 60amp are just two of the products we use with great success!
